MEMO

Houston Engineering, Inc.

Subject: Hugo Victor Gardens Development
Subsurface Water-Level Evaluation

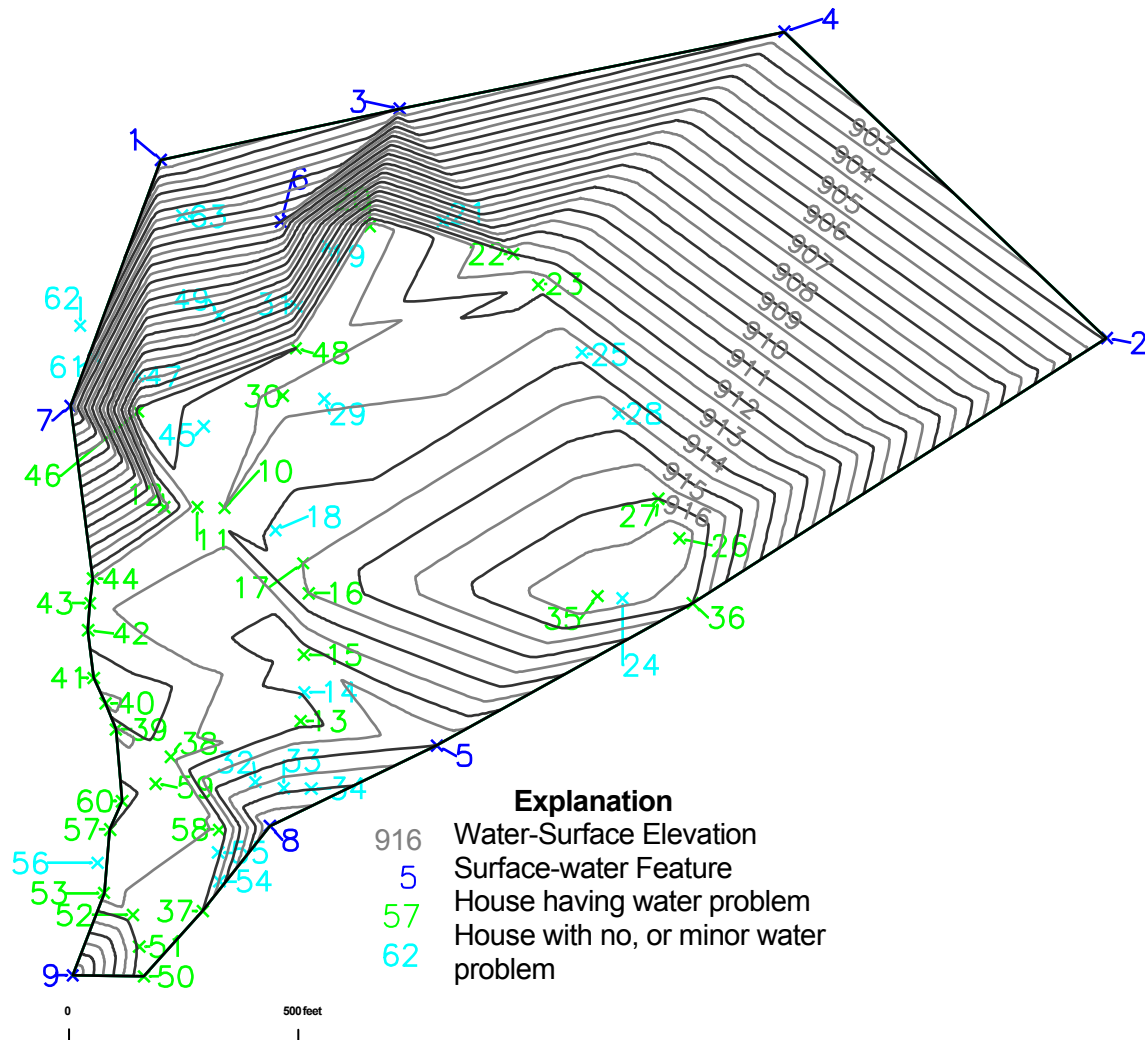
Figure 2 – Computed ground-water surface elevation and control points for Victor Gardens Development, Hugo, MN [number is site identifier in Table 1]

Figure 2 shows the results of interpolating elevation between points labeled green that intersect with and define the ground-water table. For this map, all homes reporting that their sump pump ‘runs all the time’ were included, as well as those whose sump pumps ran during the winter-months when runoff from impervious surfaces should not occur. Also included and labeled green were homes where the homeowner described that their sump pump ‘occasionally’ ran, or ran very little in the winter suggesting that their unqualified answer would have been ‘Yes’. The dark blue points along the periphery of the development are the surface-water features described previously. The points labeled light blue show the location of homes that did not have water problems at a magnitude that met criteria for defining the water-table elevation.

In most cases the elevation of the basement of the ‘dry-basement’ homes labeled light blue are considerably higher than the indicated water-table surface elevations. One exception is house number 4519 along Cosette Lane (point 25), but the computer-generated water-table contour lines may not represent the actual water table in this undefined part of the water-table contour map.

Only one elevation point (light-blue point 63 in the northwest part of the development) where a homeowner reported that their sump pump ran in the winter was eliminated from the computation of the ground-water level. Including it would have resulted in an anomalous water-level gradient in the northwest part of the development that appeared inconsistent with the other nearby water-surface elevation points including surface-water bodies and homes where sump pumps ‘never run’ or run only when it rains, but not in the winter. If the reported operation of the sump pump was not in error, it could indicate a localized hydrologic anomaly, such as a preferential flow path of water from a higher elevation to this foundation. Even with that point removed, the ground-water surface gradient from

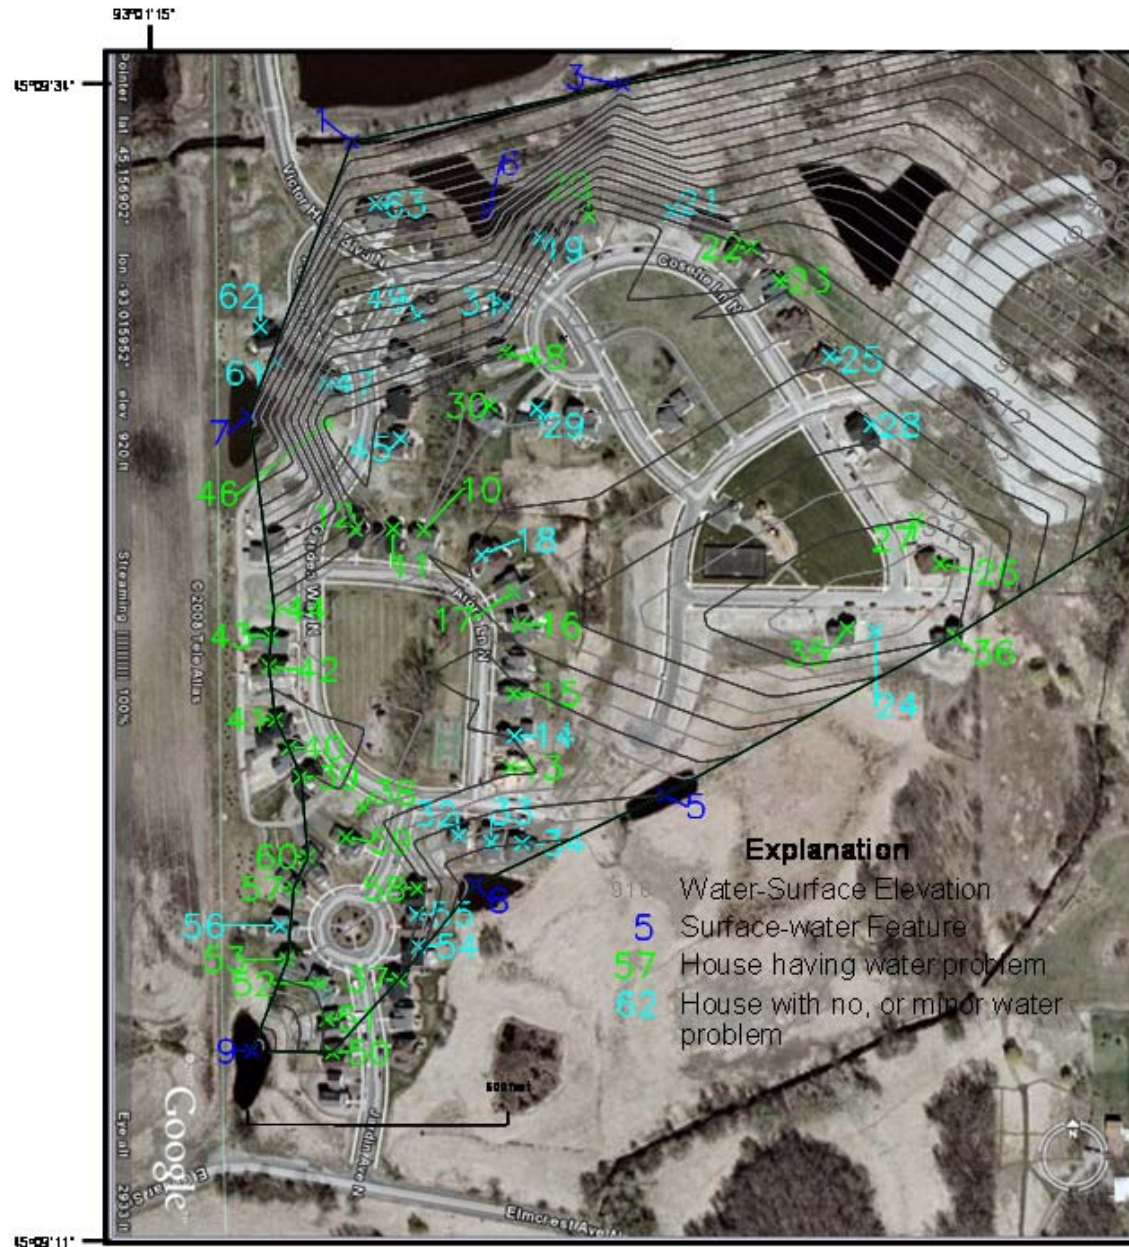
Figure 3 – Ground-water surface elevation projected on map of Victor Gardens Development, Hugo, MN [number is site identifier in Table 1]

The ground-water surface elevation contours in **Figure 2** were overlaid on the aerial photo of Victor Gardens shown in **Figure 1** to produce the illustration in **Figure 3**, but not showing the eastern extension of the ground water table beyond the development. The ground-water surface elevation in **Figure 3** was highest at the eastern side of the development at data points 26, 27, 35, and 36 which is near where Garden Way and Cosette Lane intersect. That greater-than 917-foot water level declined about 1 foot per 300 feet toward water-affected homes in the northwest, then rapidly declined toward the elevation of surface water features beyond: ponds and Clearwater Creek. The decline in water-table elevations to the northeast also was rapid, but data points to provide better definition of that decline were lacking giving the water-table decline a uniform appearance.

Less than 500-feet west and southwest of the 916-foot water table elevation, homes having a foundation only about 2.5 feet lower were intersecting the water table. From this region on, the water-table elevation appears to generally flatten out, presumably being influenced by subsurface materials that restrict the ground-water flow. Assuming that the pond elevations chosen for this model of ground-water elevations are reliable, data points 9 and 8, named Southwest Pond and Southeast Pond, respectively, have a strong local effect on the ground-water table as indicated by the steep elevation gradient drawing water from near homes that are affected by ground water.

Homes in the southwest part of the development had the greatest likelihood of having wet-basement problems because they intersect the modeled ground-water table. Whereas the Southeast Pond (point 8) appears to create a sufficient gradient to drain water away from homes in its vicinity, the influence of the Southwest Pond is inadequate to reliably protect those homes. Nearly all the homes adjacent to the abandoned Elmcrest Ave. alignment north to the Northwest Pond (point 7) have wet-basement problems with foundation elevations between 913 and 915 MSL, with no apparent place for the water to drain. It is possible that the Elmcrest Ave. road grade, which was observed to be at least 6-feet higher than the adjacent driveways and yards, or other features create a dam that retards the flow of water away from the foundations.

The water-table contour map shows a strong vertical gradient in the northwest part of the development. The 914.3 MSL water level producing a wet basement at house 14304 Garden Way (point 46) drops about 9 feet within 150 feet to the Northwest Pond behind the house. A notable decline also is apparent where the water table at 4429 Cosette Lane (point 20) tapers north toward Clearwater Creek. The northern-most house in the development, at point 63, reporting sump-pump operation suggesting a wet basement at elevation 914 MSL was not used in this estimation of the ground-water table elevation. It is located nearly between two surface-water features, points 1 and 6, at elevations of 900 MSL and 905 MSL, respectively. The northwest part of the development had complicated surficial geology where till and outwash intersected suggesting a complex hydrology that might result in these irregular reports of sump-pump activity. The geotechnical evaluation report suggested perched water tables in the development, and those could be upwelling in this area. However, the nearest soil boring was at the North Pond (point 6) north of these homes so it does not indicate what conditions were like at the affected homes.

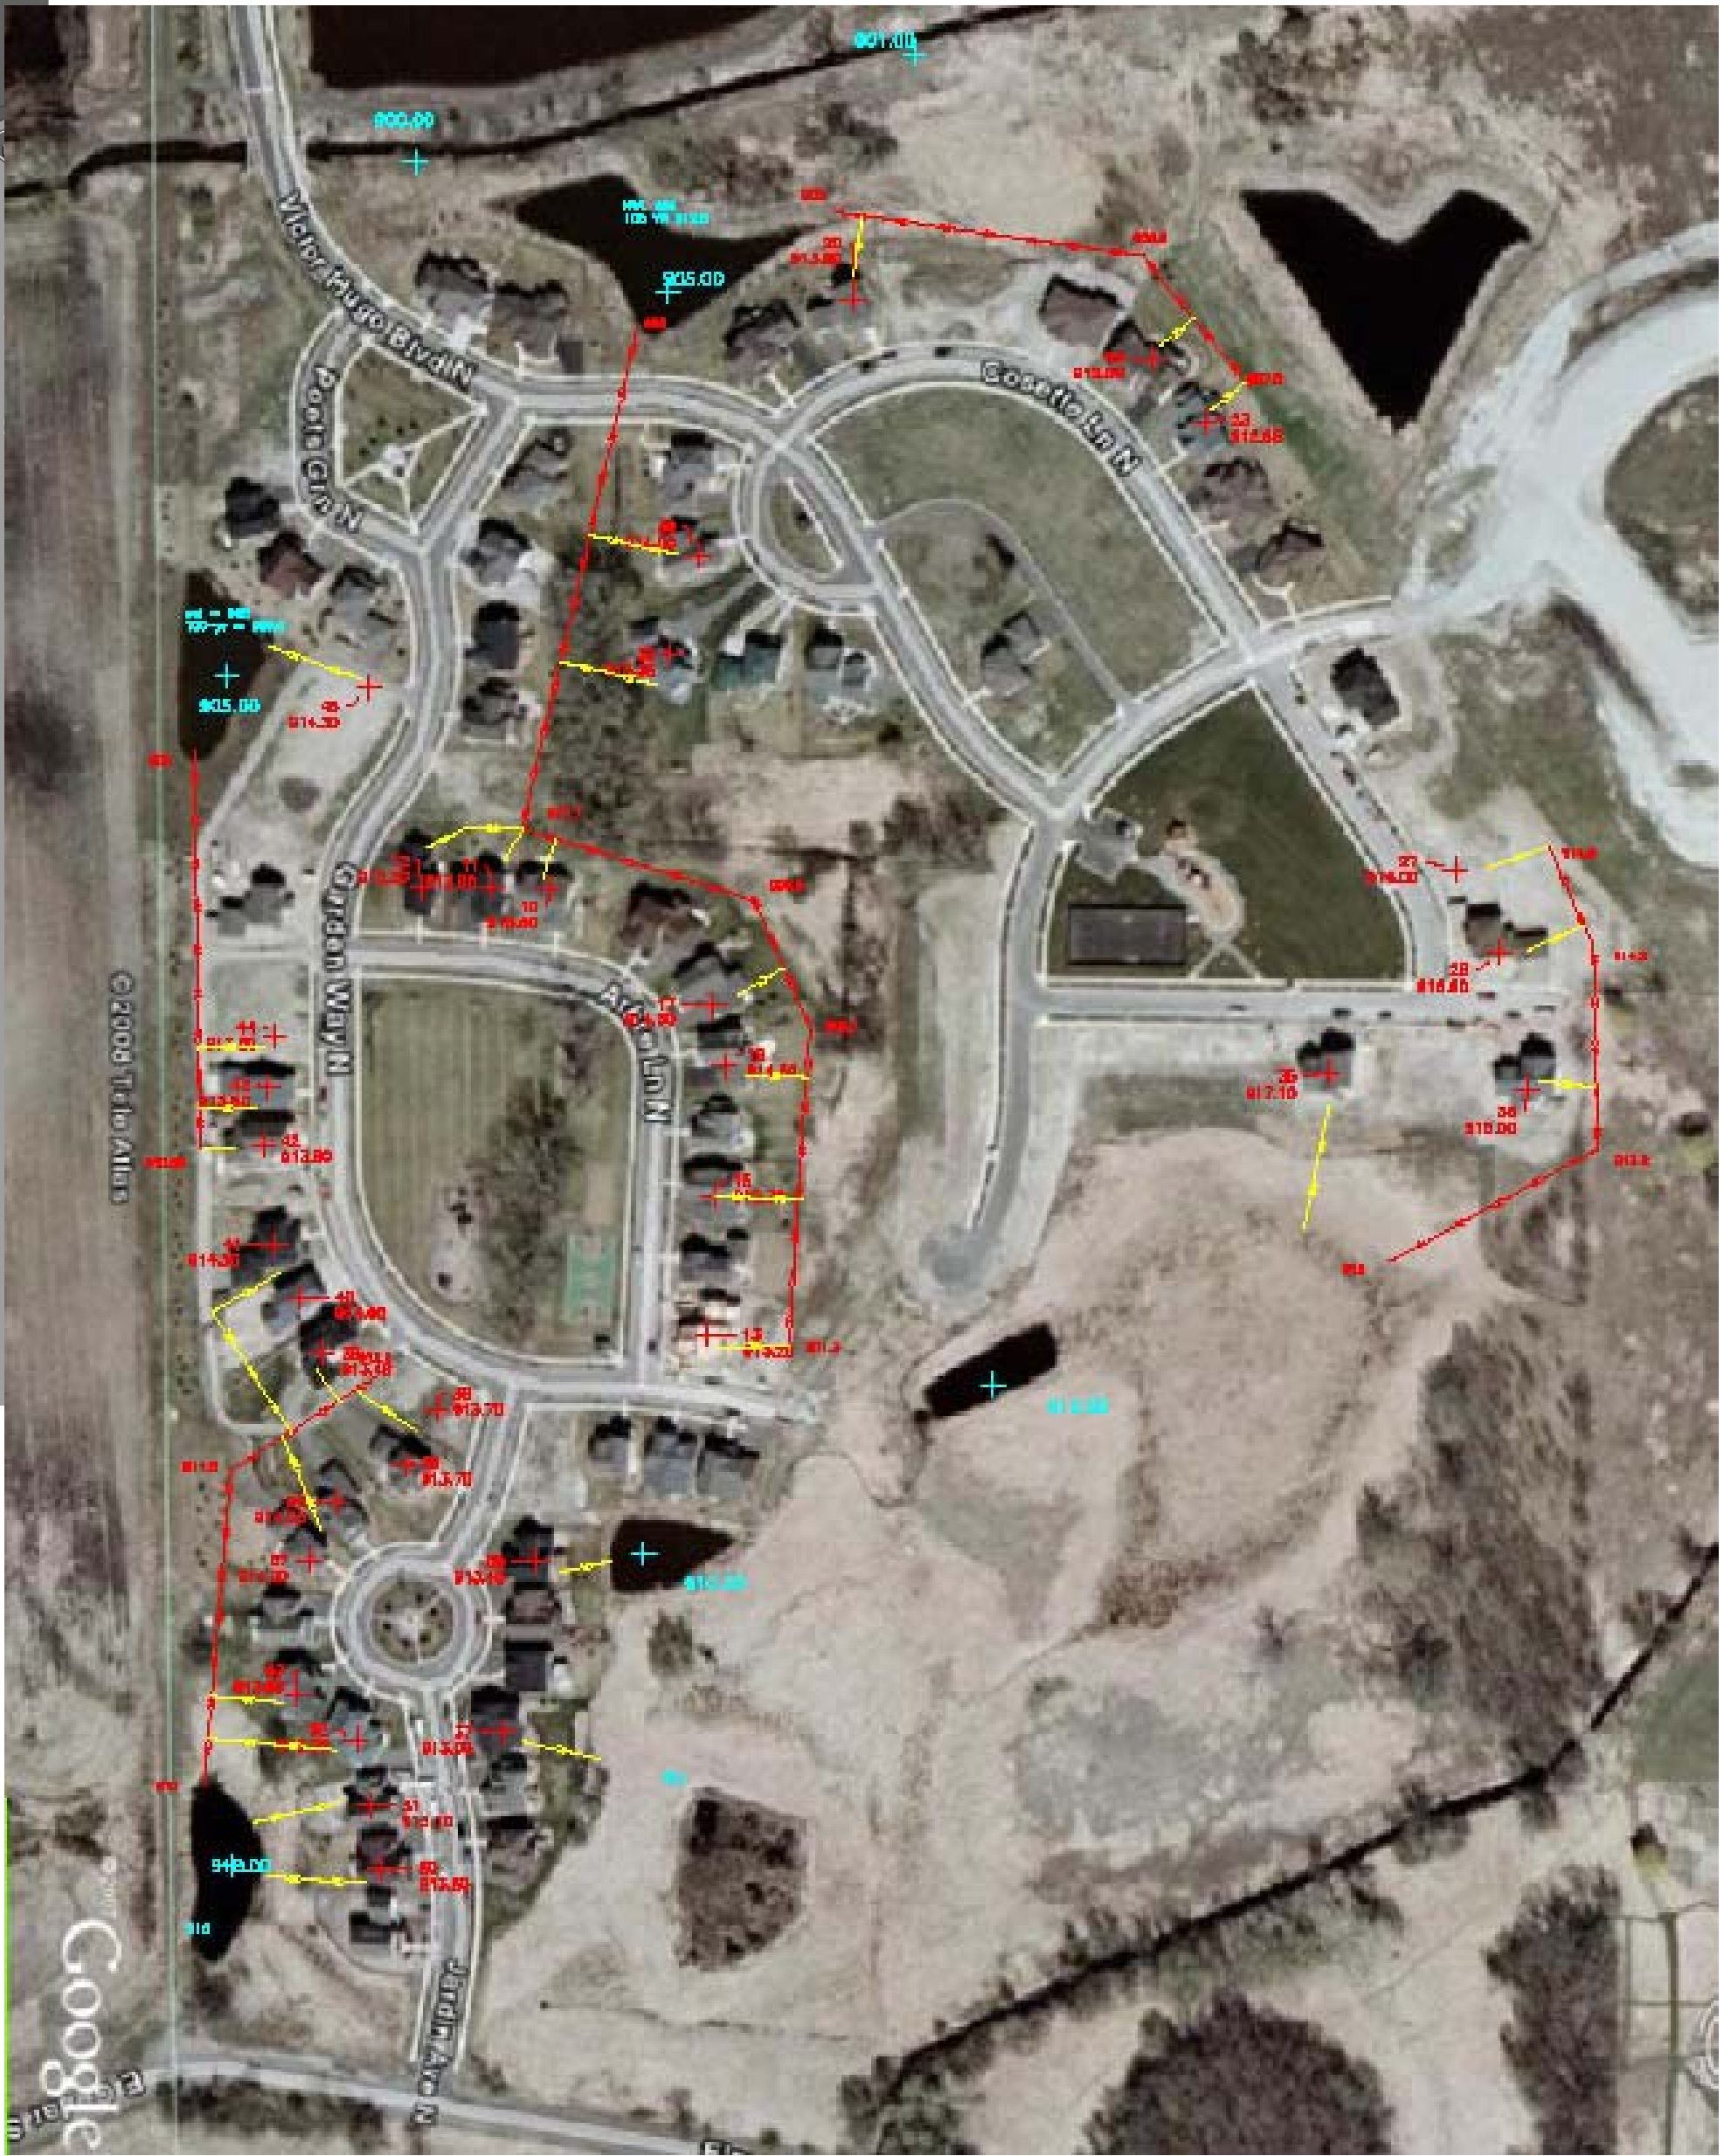
Figure 4 – Diagram of foundation-drainage system proposed for the Victor Gardens Development, Hugo, MN

Multiple homes along Arbre Lane have water problems that are not adequately drained into the low area behind the homes. That low area appears to have an elevation of 916 feet which is higher than the affected-basement elevations; this elevation anomaly was verified by RCWD staff. Because that low area appears inadequate, it should be further excavated, but **Figure 4** shows installation of a

Figure 4 shows a proposed drainage system to convey water away from affected homes. Two sizes of pipe are employed: 4 inch pipes shown in yellow drain from individual homes or pairs of homes, while 12-inch pipes shown red accumulate water from the 4-inch pipes and convey it to downstream basins. A 12-inch pipe could be buried along the base of Elmcrest Ave. beneath an existing alley extending north to the northwest pond (point 7) with a final elevation consistent with the 100-year pond elevation (less than 910 feet). The foundations of homes adjacent to the alley west of Garden Way would be connected to that pipe.

buried pipe that runs to the north pond (point 6). Water-affected homes along Arbre Lane the western loop of Cossette Lane should be drained to that conveyance.

Each home having water problems along the northern loop of Cossette Lane could have a gravity drain installed from their foundation drainage system to the lowest nearby water body: the north pond (point 6). The homes having water problems in the eastern part of the development where Cossette Lane meets Garden Way could drain from their foundation drainage system to the wetland area to their south. Each home having water problems in the southern part of the development along Jardin Ave. could have a gravity drain installed from their foundation drainage system to the wetland area to the east or the pond to the southwest (point 9; assuming that pond drainage is assured as described earlier in this memo).

The information provided in **Figure 4** was used to estimate the cost of installing this proposed drainage system. The total cost is estimated to be about \$191,000 as detailed in **Table 2** and would serve 30 homes at \$6,400 per home. This cost does not include additional engineering and site inspections that will be needed to ensure the success of this proposed project. Existing foundation drain systems should remain in place for backup purposes. If any of the foundation drainage systems are installed inside rather than outside the foundation, the foundation may have to be penetrated to access the existing foundation drainage.
