MEMO

Houston Engineering, Inc.

Subject: Hugo Victor Gardens Development
Subsurface Water-Level Evaluation

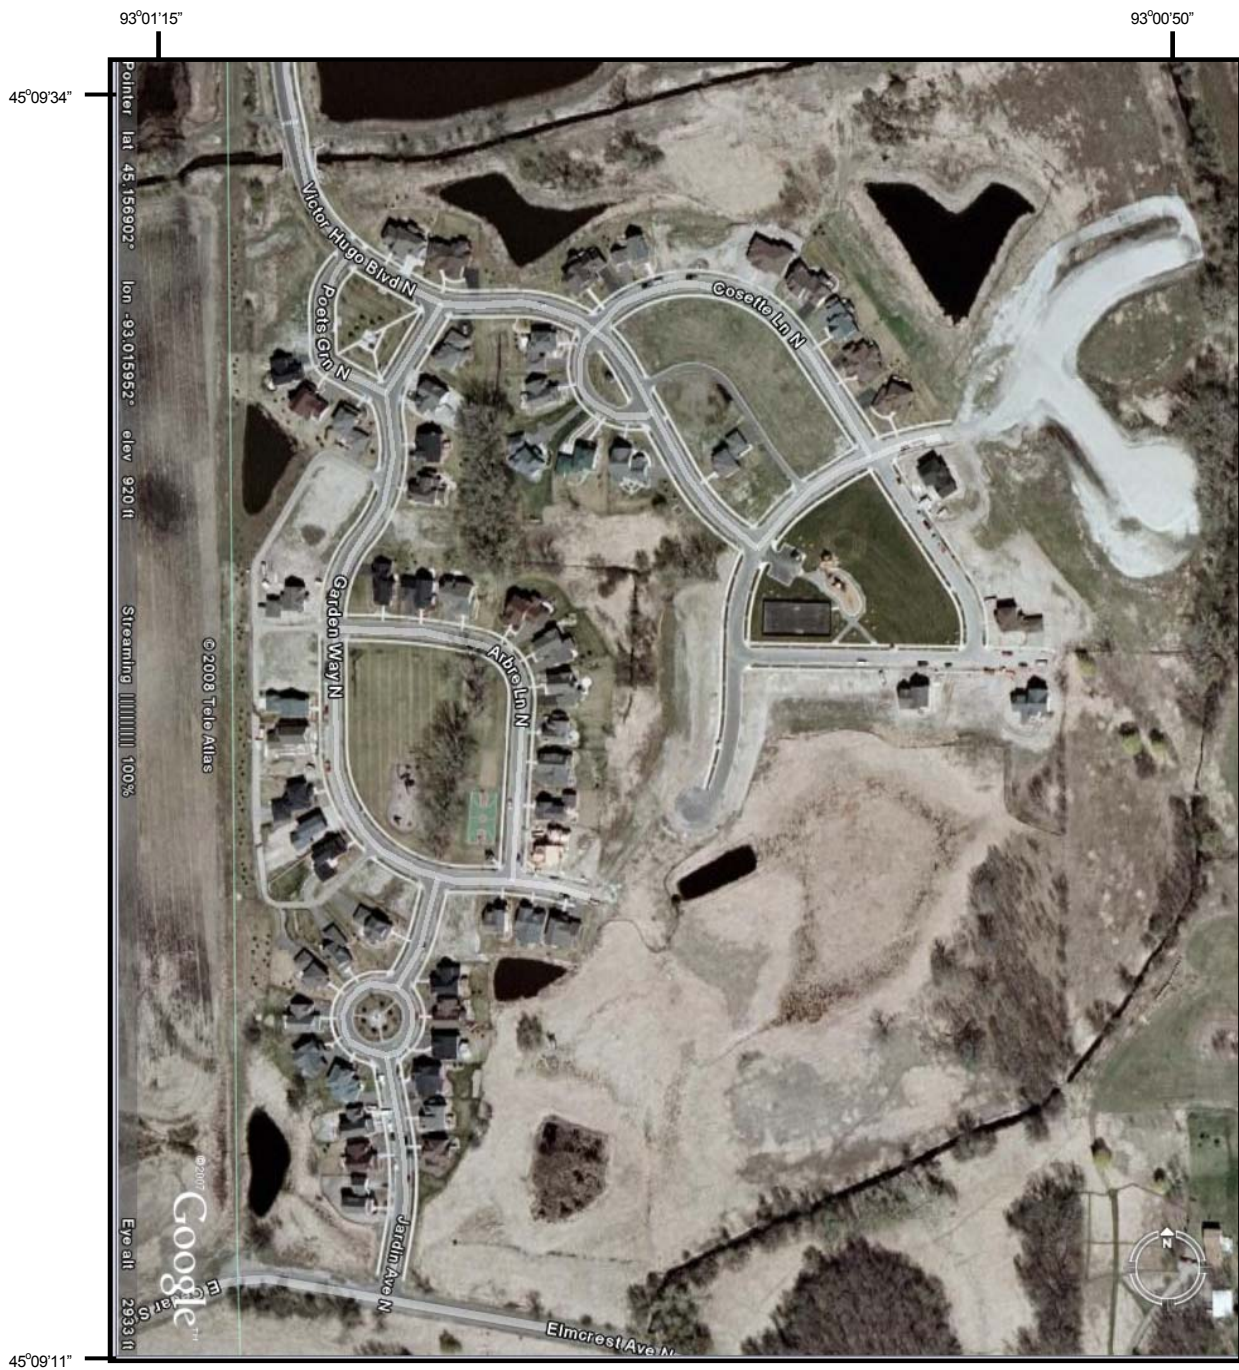
Figure 1 – Victor Gardens Development in Hugo, MN
Showing Location of Houses and other features used
as Measurement Points

Figure 1 is an aerial photograph that shows the layout of the Victor Gardens development including the houses and surface-water features. Although it is not evident when the photograph was taken, it shows vacant lots where homes are known to exist. The development is relatively flat with the highest point having an elevation of about 922 feet above mean sea level (MSL) along Arbore Lane near the center of the development down to 900 MSL near Clearwater Creek which is north of the development.

There are gaps in the data used to estimate ground-water levels that may need additional definition. These gaps are in common-space areas where homes were not established but that may be crucial to understanding how the shallow groundwater interacts with the foundations of affected homes. There is a notable gap where Victor Hugo Blvd. ends at a park east of the center of **Figures 1 and 3**, and where the highest ground-water elevations are indicated. A similar gap occurs in the park
